Service Bulletin

No 14 rev 3 2008-04-08

Non return valves for protection of air distributor CD Units.

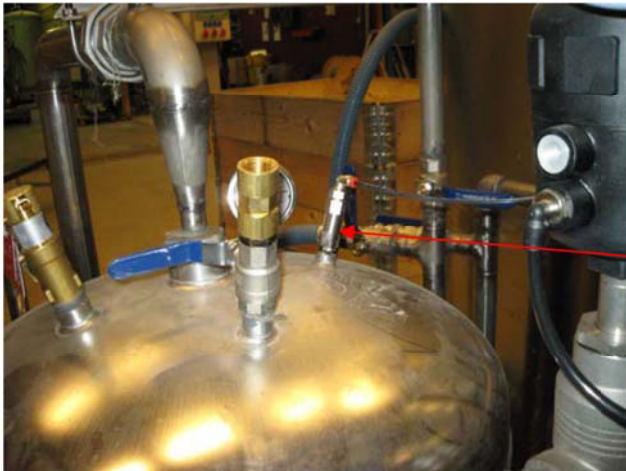
Non return valve #137
16101

We have experienced damaged to the air distributor in the electric cabinet caused by water penetration on some vessels. This has been caused by leakage of the non return valve #137 on the circulation tank #52. See picture below:

In order to avoid and correct this problem Marinfloc recommend that the non-return valve is checked for leakage and replaced if necessary. Marinfloc also recommend that an extra non return valve is added to the hose after the air adjustment valve #136 for extra safety. See picture below:
