Service Bulletin

Priority RED No 15 2008-07-10

Note: Only applicable to CD 2 & 5 Units.

Flocculation tank critical vibrations.

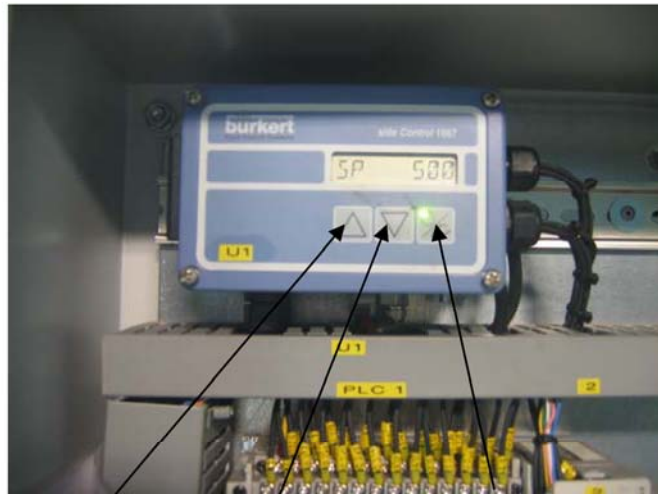
Arrow up (1) Arrow down (2) Menu button (3)

In order to reduce the stress to the flocculation tanks and the risk of cracks we have lowered the recommendation for the PID Set Point from 800 mm to 500 mm. This will significantly reduce the water amount in the tank. Hence the weight will be less as well as the stress levels and the process more balanced.

The PID regulator can be found in the top left corner of the control cabinet.

1. When the unit is running, toggle to SP by means of the UP(1) and DOWN(2) arrows.
2. Press and hold the DOWN(2) arrow for a few seconds until the display changes to adjustment mode.
3. Adjust by means of the UP and DOWN arrow and enter/step forward with the MENU(3) button.
4. Make sure the LED light on the MENU(3) button is lit when you are finished. If not, press it once.
